**TEST REPORT No. 135/BT/2024**

Subject:	Testing the IP68 ingress protection rating of "QuSpot series" enclosures
Orderer:	Wireless Instruments Kościuszki 27, 52-116 Iwiny
Project No:	UP/BT-33346/OR1
Release date of the Report:	27.09.2024
Date and place of tests:	16-25.09.2024 at the KOMAG Institute of Mining Technology at Pszczyńska 37 in Gliwice, Poland

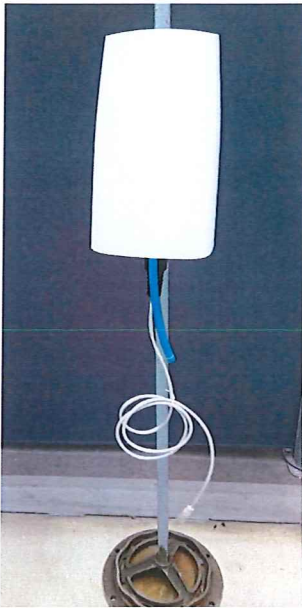
Fig. 1. Tested object sample no. 166/24/1

- 166/24/1 – IP6X test (S/N: 45773)
- 166/24/2 – IPX8 test (S/N: 45774)

After the test for the first characteristic numeral IP6X, no dust was found inside the tested enclosure.

***Test result for the first characteristic numeral IP6X of the tested enclosure is positive.***

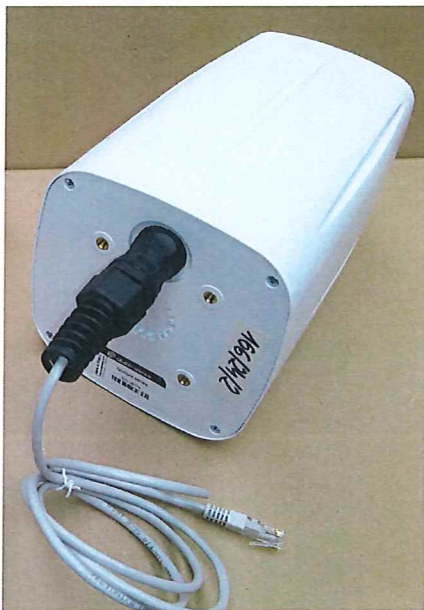
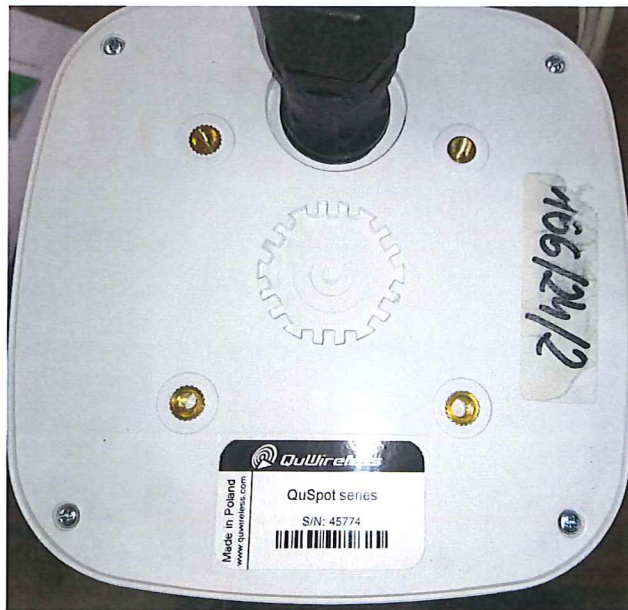
Fig. 2. Tested object sample no. 166/24/2

After the test for the second characteristic numeral IPX8, no water was found inside the tested enclosure.

***Test result for the second characteristic numeral IPX8 of the tested enclosure is positive.***
