REPORT

No. 86/BT/2014

Subject: Testing the IP67 protection class of WiBox Large enclosure

Orderer: Wireless Instruments Sp. z o. o.

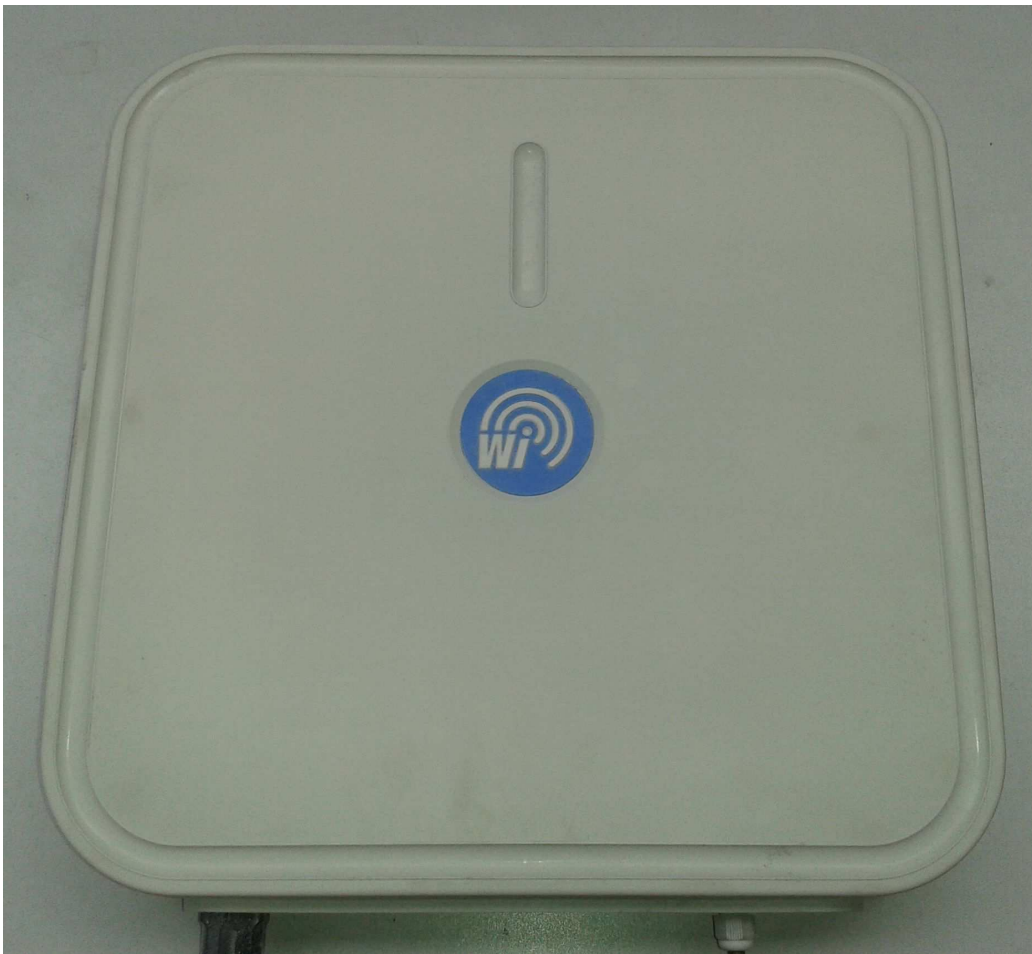
Fig. 1. View of the tested object

View of the tested object is given in Fig 1.
